Manhole Inspection Summary

Manhole # S21K__001MH

Insp Date: **4/2/08 12:10 PM**

Location Address: **1902 s monroe-goldsmith alley**

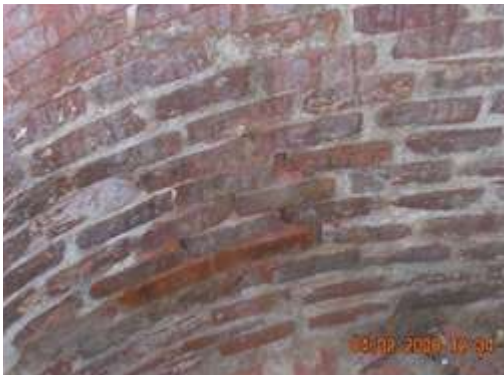
Defect 2

Condition: ☐ Sound ☒ **Cracked** ☐ Root Intrusion ☒ **Loose Brick** ☐ Deteriorated

cracked and loose barrel bricks

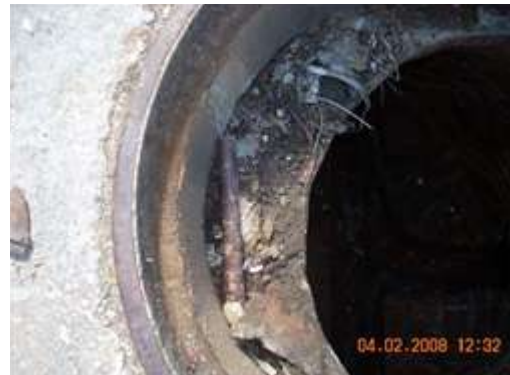
Defect 1

Offset: **5** (in.)

frame offset

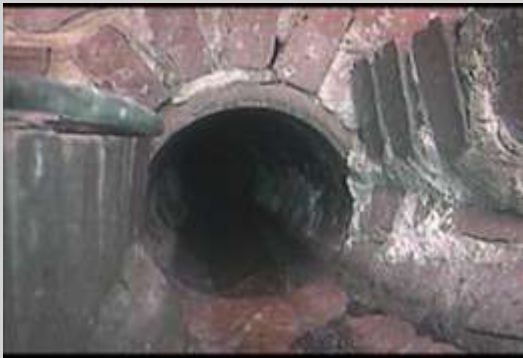
12 O'Clock Outflow

Pipe Height: **8.4** (in.) Rod and Bar (Angled)
Pipe Material: **Clay** ☐ Pipe Lined
Invert Depth: **6.92** (ft.) Flow Characteristics: **Slow**
Deposits: ☒ None ☐ Mud ☐ Sludge ☐ Debris ☐ Grease
Silt Depth: **0** (in.) Deposits Extent:
Infiltration: **None** Pipe Seal Cond: **Sound**

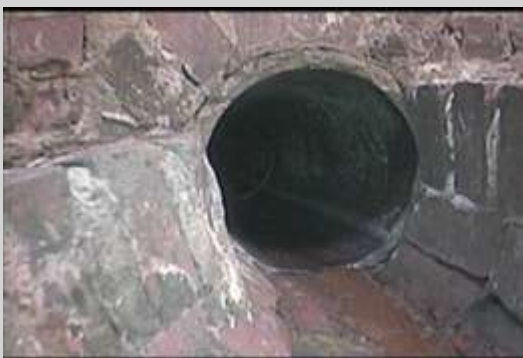
3 O'Clock Inflow

Pipe Height: **8.4** (in.) Rod and Bar (Angled)
Pipe Material: **Clay** ☐ Pipe Lined
Invert Depth: **6.34** (ft.) Flow Characteristics: **Slow**
Deposits: ☒ None ☐ Mud ☐ Sludge ☐ Debris ☐ Grease
Silt Depth: **0** (in.) Deposits Extent:
Infiltration: **None** Pipe Seal Cond: **Sound**

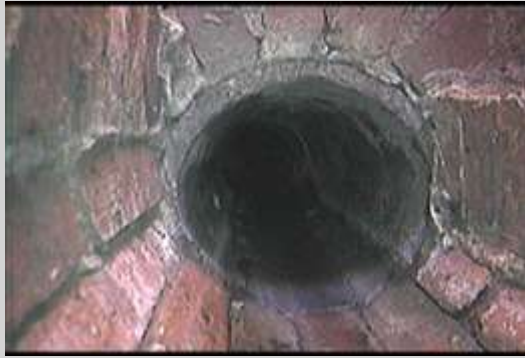
6 O'Clock Inflow

Pipe Height: **7.2** (in.) Rod and Bar (Angled)

Infiltration: **None** Pipe Seal Cond: **Sound**
